Debris/Ice/TPS Assessment And Photographic Analysis For Shuttle Mission STS-31R

June 1990

Charles G. Stevenson
NASA/Kennedy Space Center

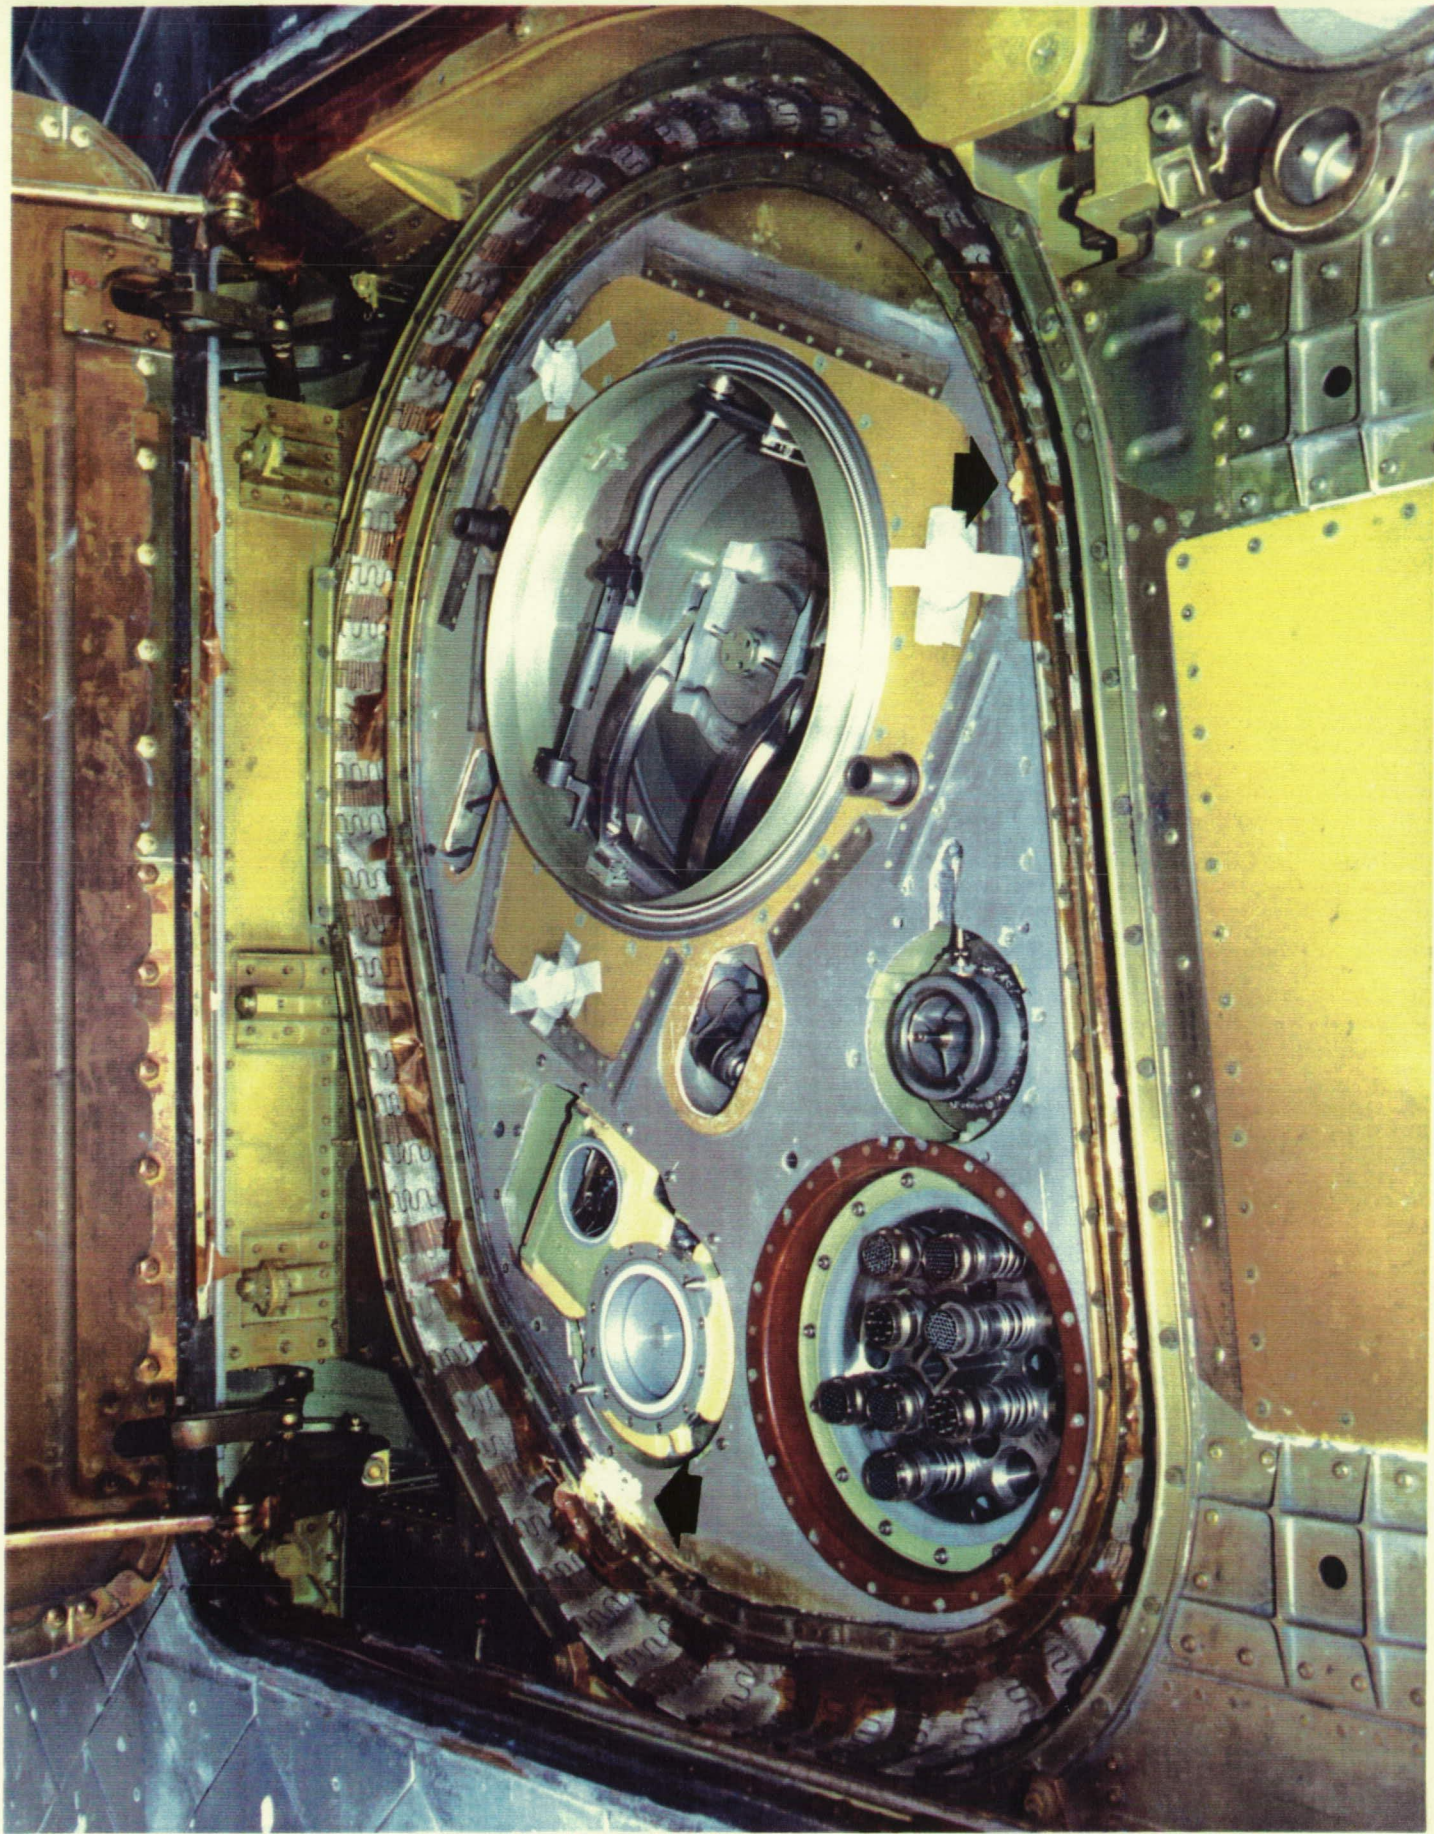
Post flight condition of the LH2 ET/ORB umbilical. Note
closeout foam intrusion along interface (arrows)

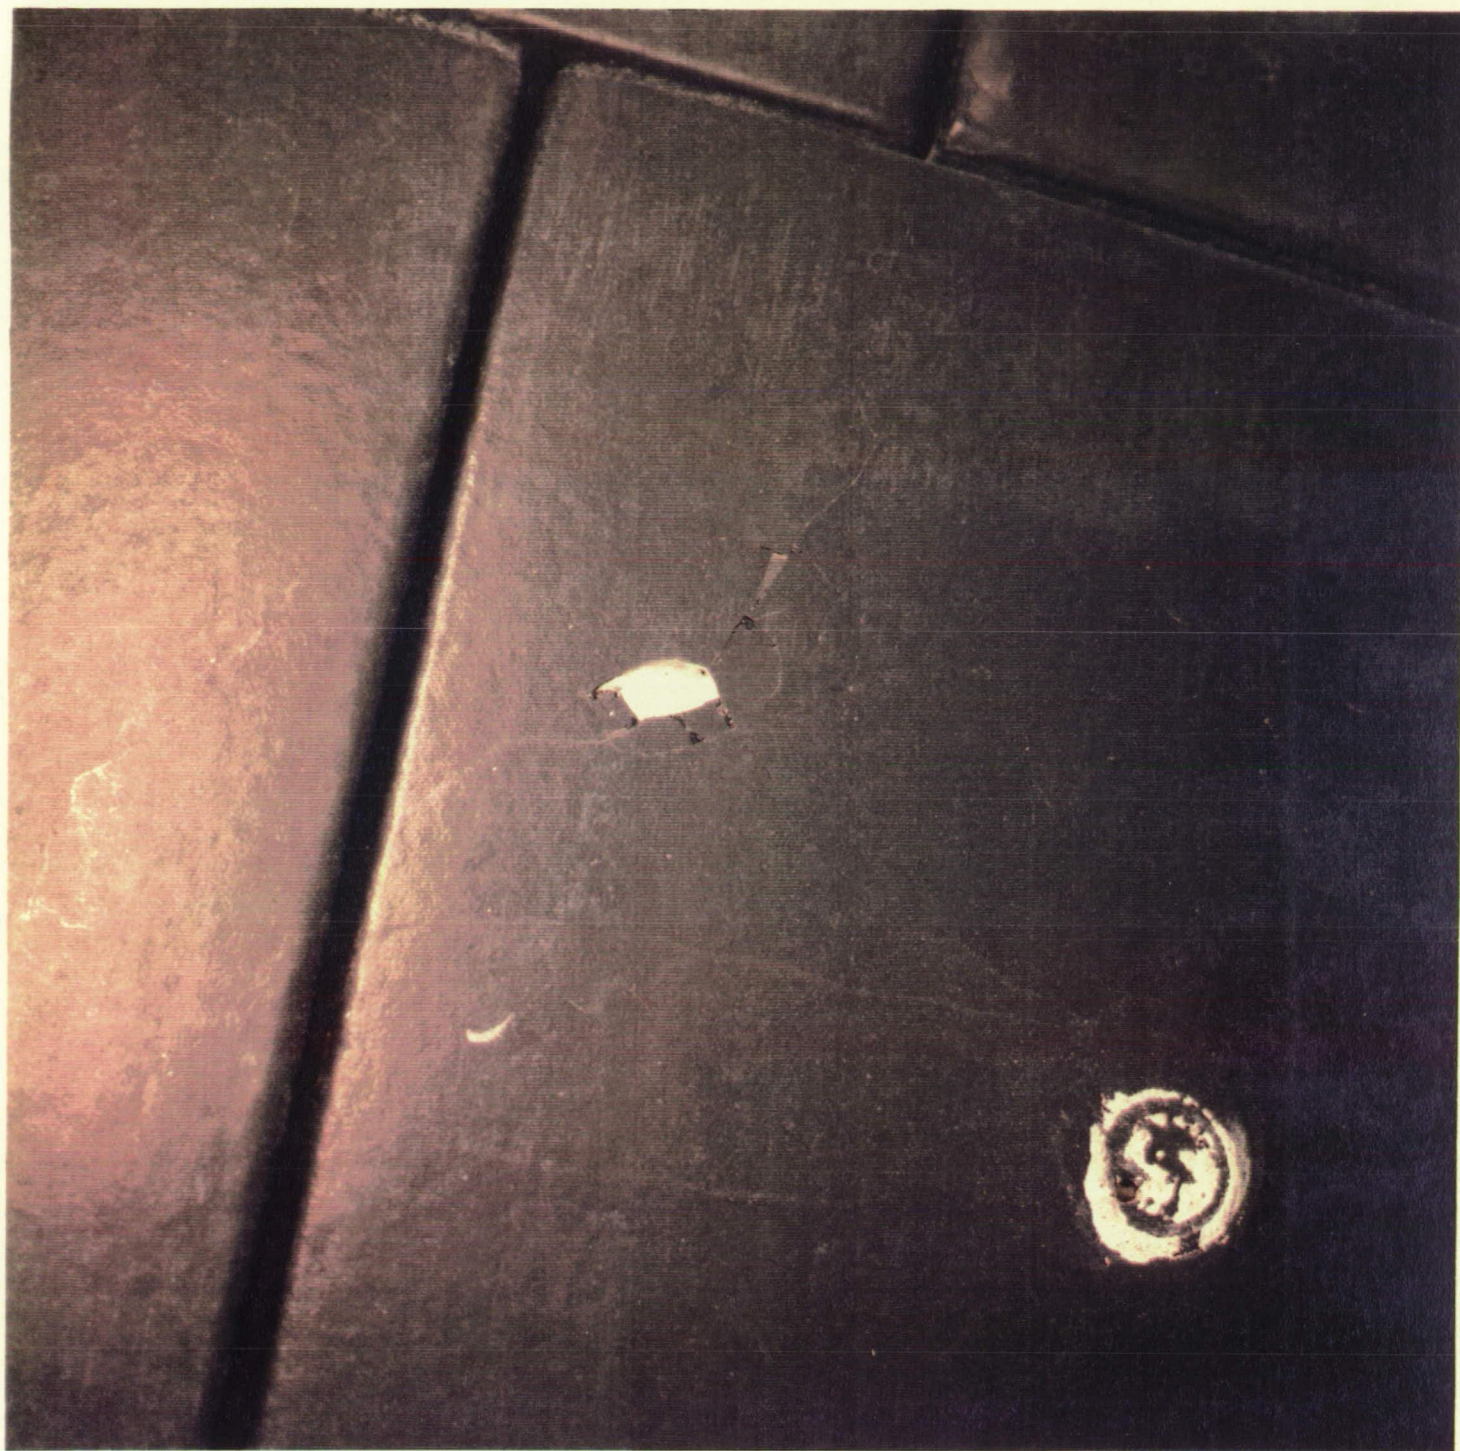
Analysis of dark residue in tile damage site cavity
revealed tile material and landing site products
152

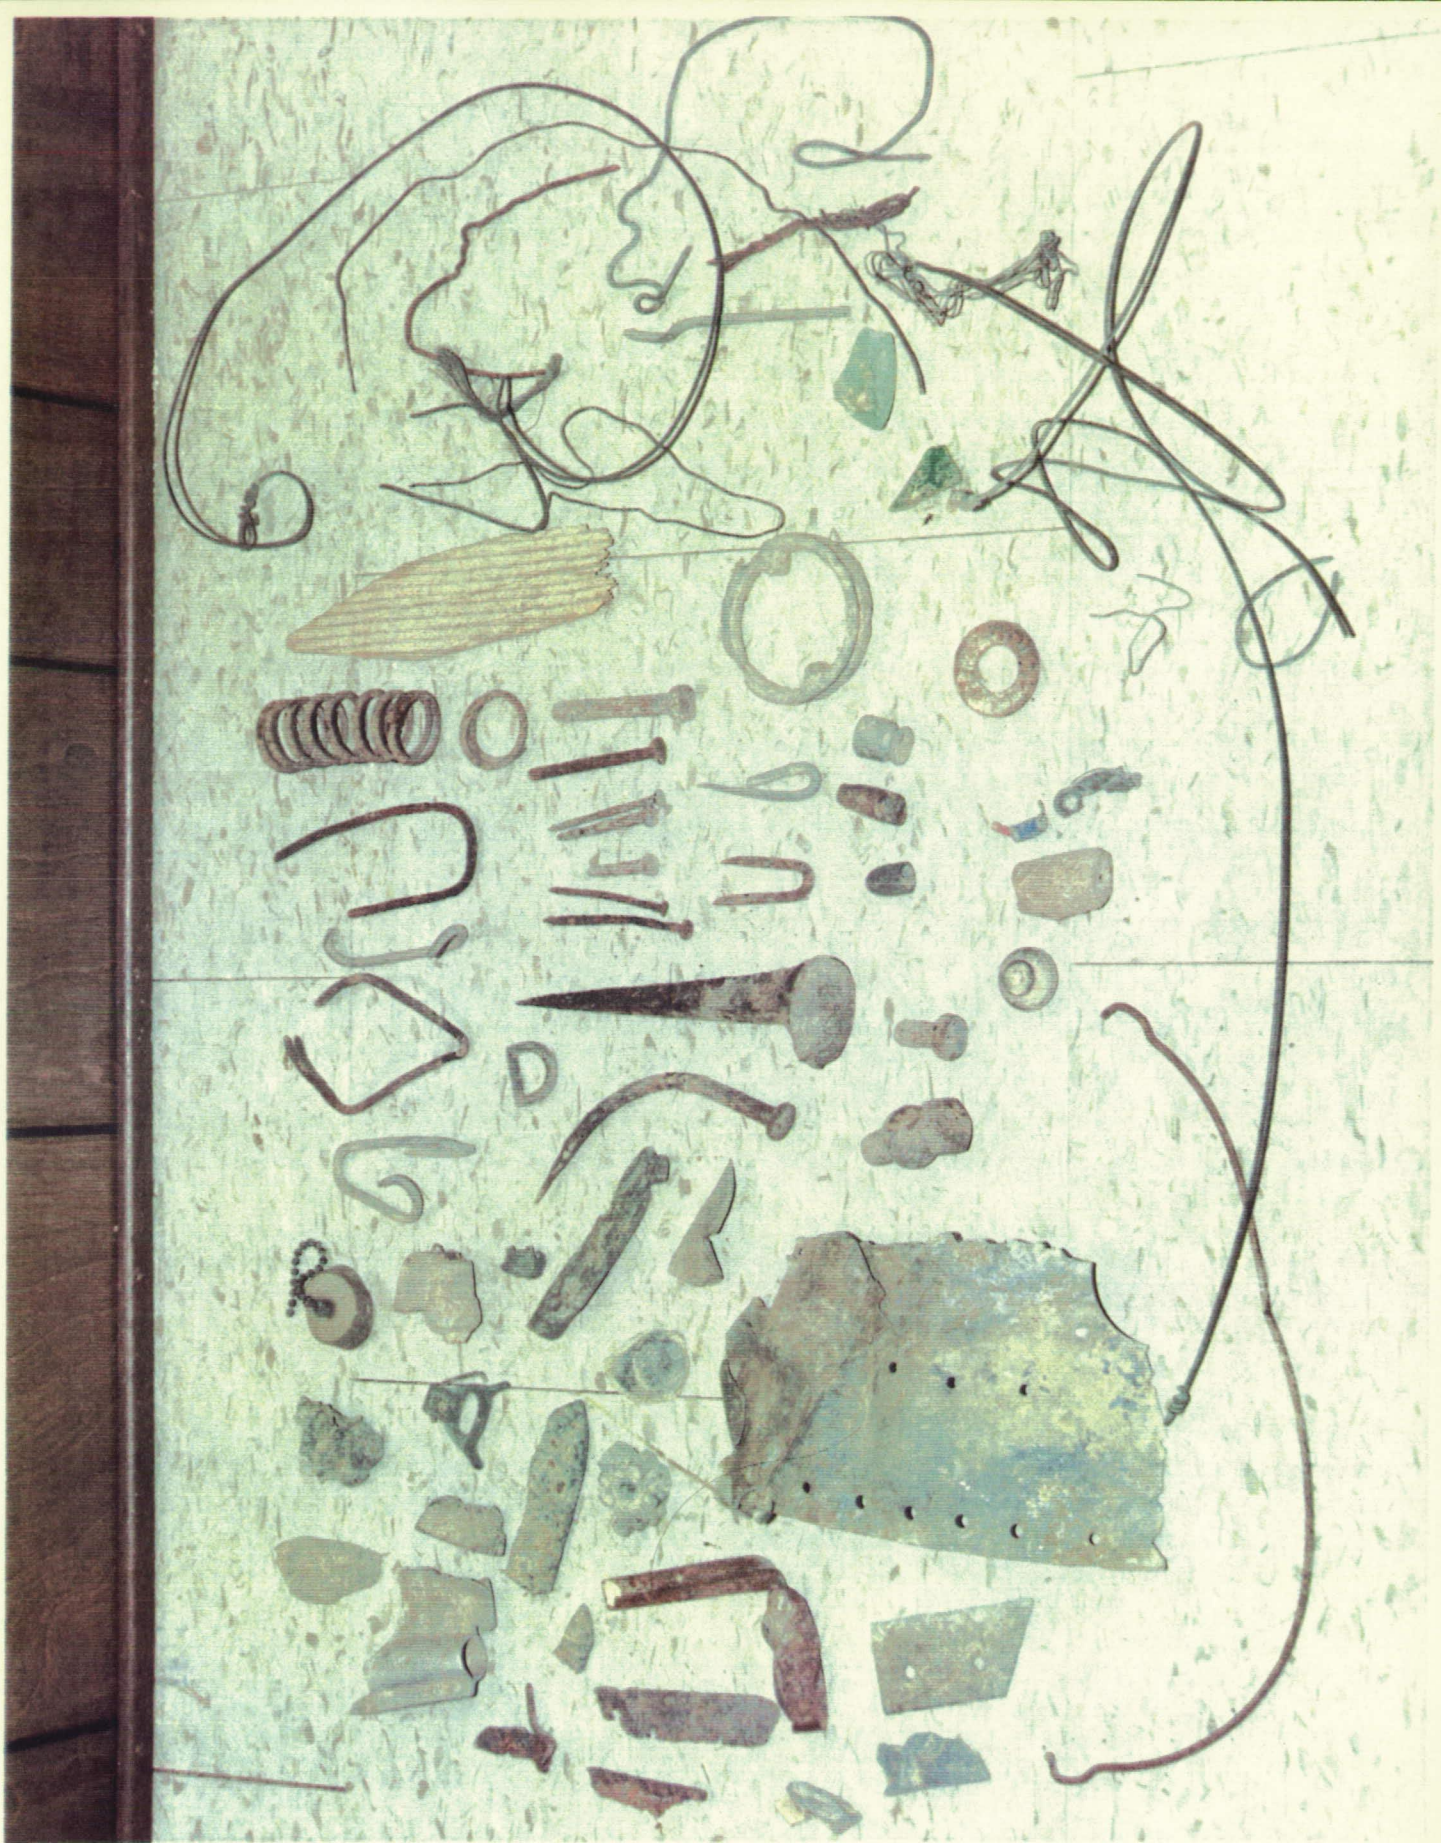
Debris collected during pre-landing runway walkdown
